FTC-TR-71-26

CATEGORY II ICING TEST OF THE HH-53C HELICOPTER

TECHNICAL REPORT No. 71-26
JUNE 1971

AIR FORCE FLIGHT TEST CENTER
EDWARDS AIR FORCE BASE, CALIFORNIA
AIR FORCE SYSTEMS COMMAND
UNITED STATES AIR FORCE

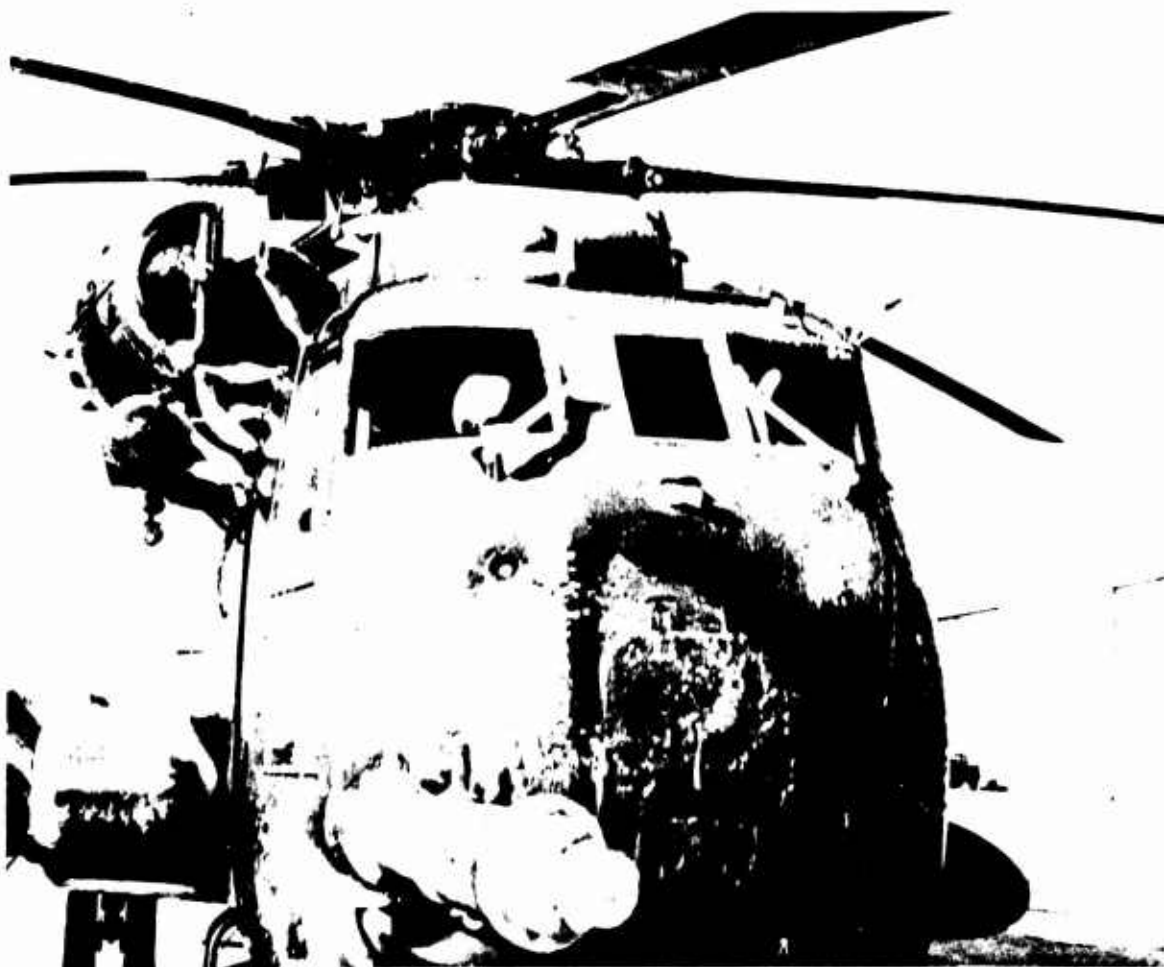
Figure 4 Typical Ice Accumulation on HH-53

Ice accumulated on the vertical pylon, horizontal tail, rotor hub, flight controls, refueling boom, external sponsons, tanks and aircraft nose (figure 4). The rescue hoist accrued heavy ice throughout most of the test conditions. Maximum ice thickness of 1-1/4 to 1-1/2 inches was accrued on the previously mentioned airframe areas from artificial icing conditions of icing flights 9, 14 and 15. No structural damage was inflicted on the HH-53C airframe during all icing tests. Ice accumulation did not hinder flight control operation.

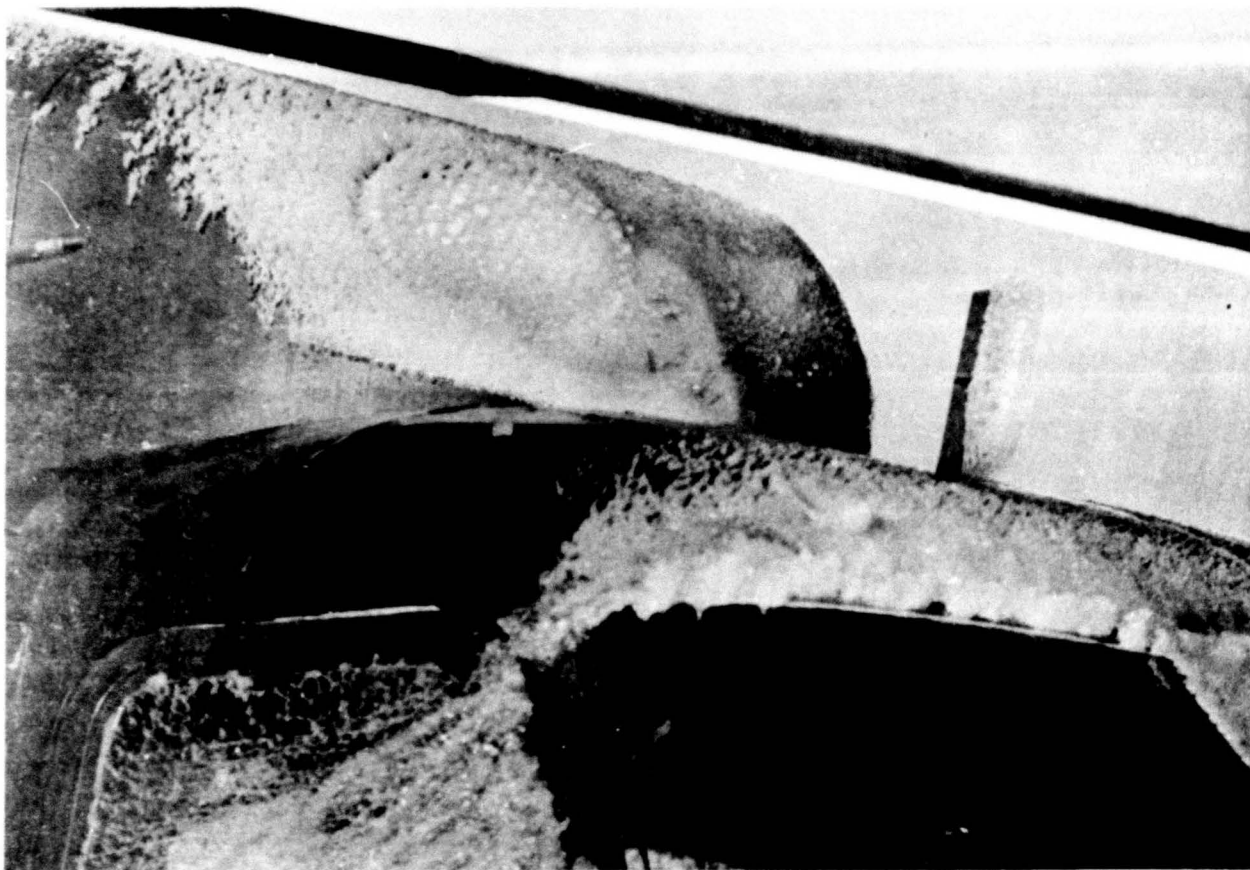
Figure 5 Iced-Over Heater Inlet Duct Screen

The cabin heater inlet screen had an estimated 75 to 90 percent airflow blockage on icing flights 8 and 9 respectively, due to glime ice formation on the screen (figure 5). Subsequent tests conducted at colder outside air temperatures (OAT) had minor (10 percent) blockage of the heater screen area (icing flights 14 and 15). The cabin heater was inoperative throughout part of the artificial icing tests; however, it was believed that this condition did not significantly change the pattern of the ice buildup on the heater screen (appendix II). The heater inlet screen could be totally blocked off by ice formations should light or moderate icing conditions at OAT's from 0 degrees C through -13 degrees C be encountered for extended periods of time. The heater was inoperative during most of the flights when significant ice accretions on the heater inlet occurred. Possible heater system damage or erratic operation due to reduced airflow might result from heater operation after the heater inlet duct was iced over. If reduced airflow from the heater outlet ducts is realized while flying in icing conditions the heater should be turned off to preclude possible heater damage. A NOTE to this effect should be included in section IX of the Flight Manual. (R 1)¹

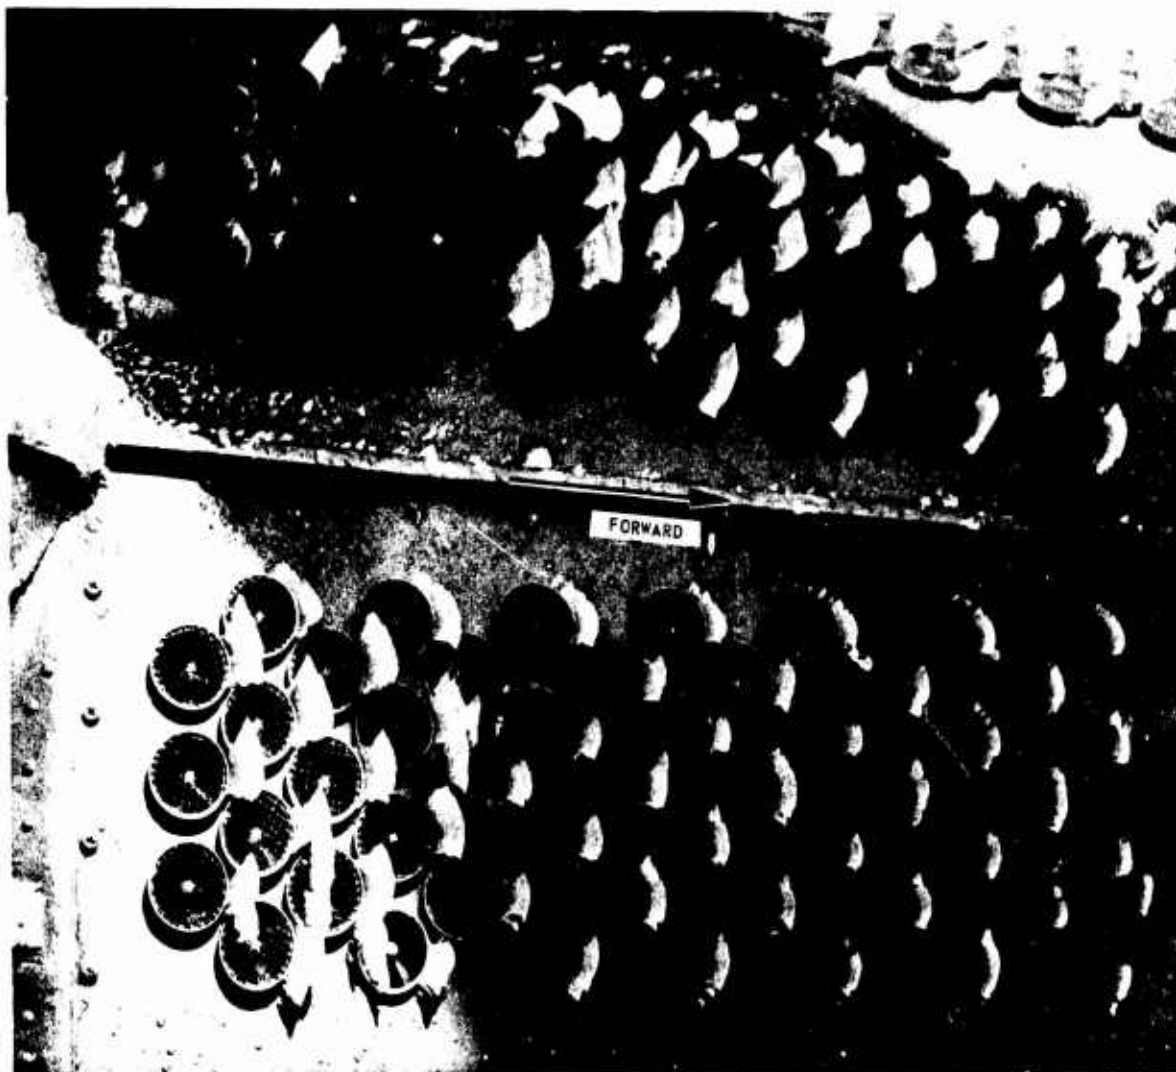
Figure 7 Ice Fingers on EAPS Mini Screens

A trace of ice buildup was noticed inside the EAPS ducting after icing flight 11 (EAPS doors opened). A maximum of 1/4 inch glime ice collected on the EAPS inlet lips and door edges. Ice fingers built up and out from the EAPS min. screens on the forward one-third of the EAPS (figure 7).

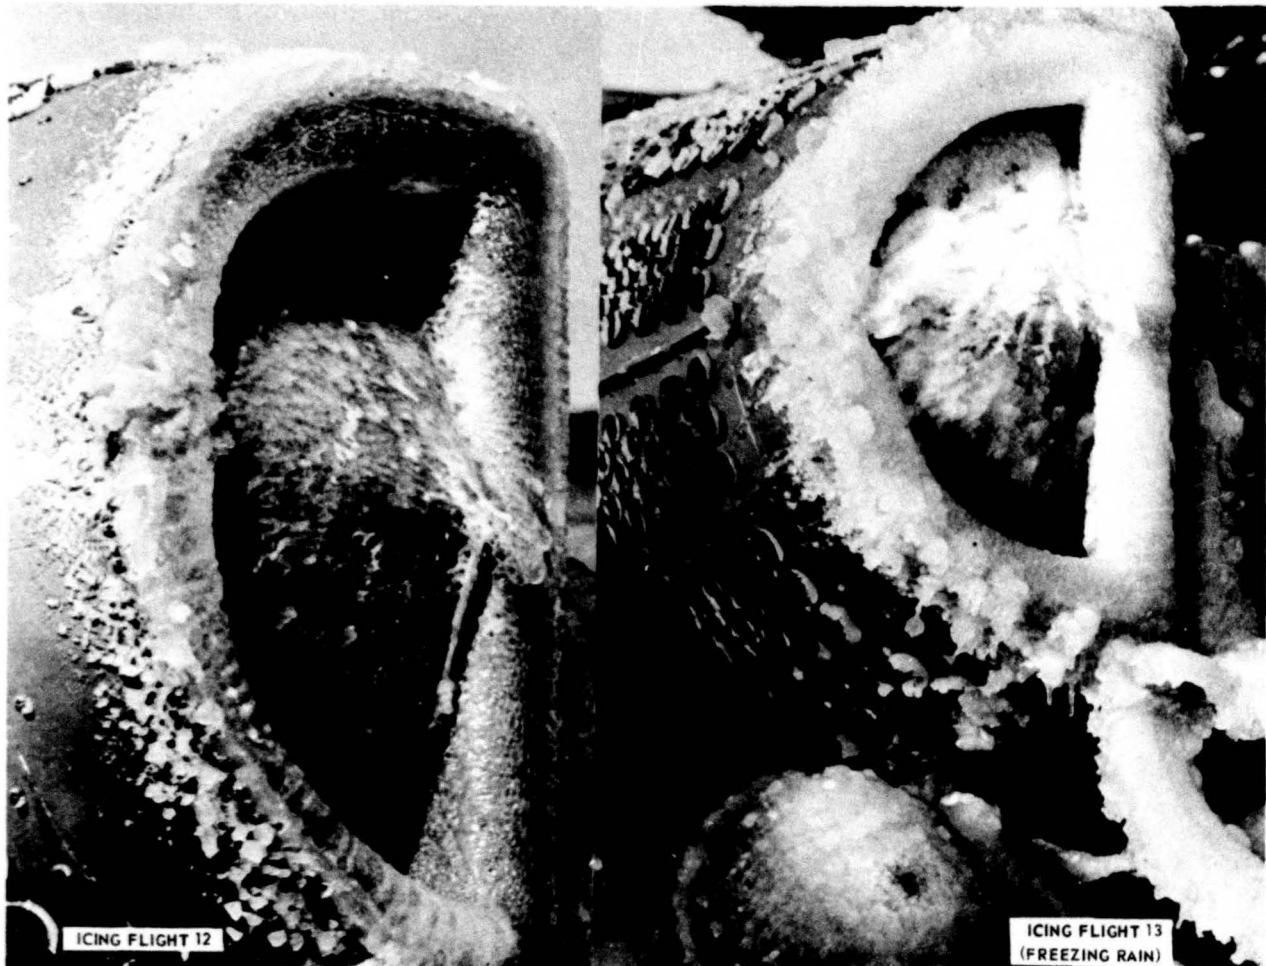
Figure 8 Solid Sheet of Ice on EAPS Lips and Doors

Icing flights 12 through 15 were conducted with EAPS doors closed. Ice accumulated 15/16 inch and 1-1/2 inch thick on the EAPS inlet lips during icing flights 12 and 14 respectively (appendix II). A solid sheet of ice formed over the doors and lips during icing flights 12 and 14

(figure 8). The approximate maximum thickness of ice on the doors was $\frac{3}{4}$ inch on icing flight 14. No ice was noticeable inside the EAPS during the artificial icing tests with the doors closed. Ice fingers formed on the leading edges of the mini screens on the bottom and the vertical inboard EAPS panel (figure 9). Maximum EAPS mini screen ice blockage was estimated at five percent on icing flight 14, appendix II.

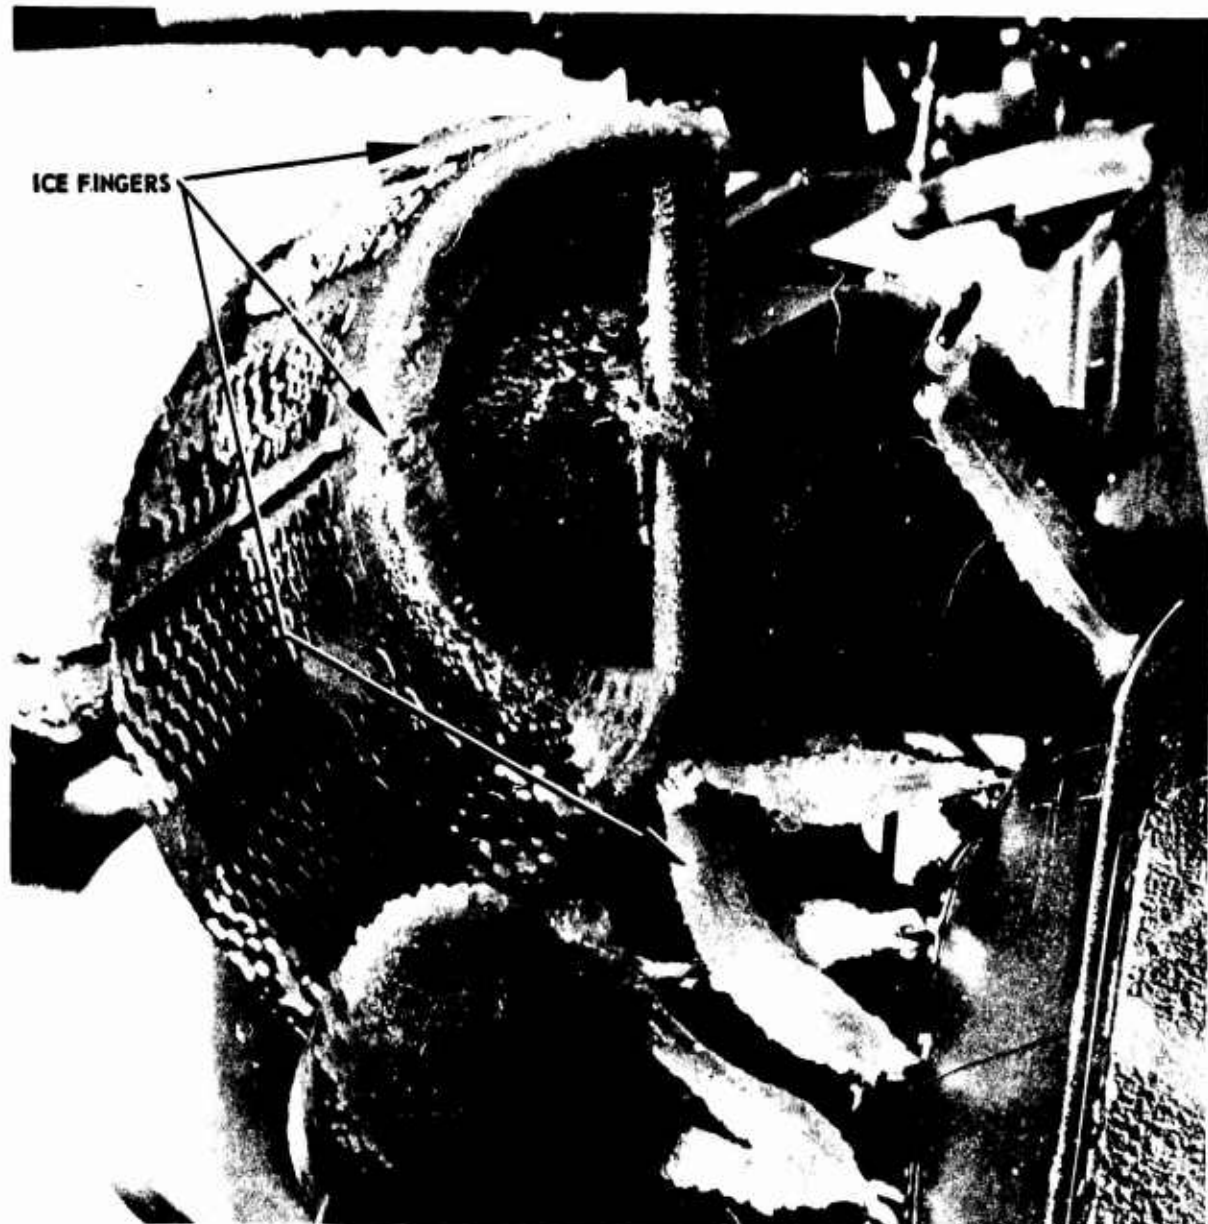
Figure 9 Ice Fingers on EAPS

Approximately 20 of the 759 EAPS mini screens were blocked with $\frac{1}{8}$ inch ice on icing flight 13 (appendix II). The inboard EAPS panel was 30 percent blocked off with ice. Ice fingers were $\frac{1-15}{32}$ inch long on the leading edge of the mini screens and on parts of the screens on the forward $\frac{1}{3}$ of the EAPS. Ice was $\frac{5}{16}$ inch thick inside of the closed EAPS on the forward lower surface, due to water runback.

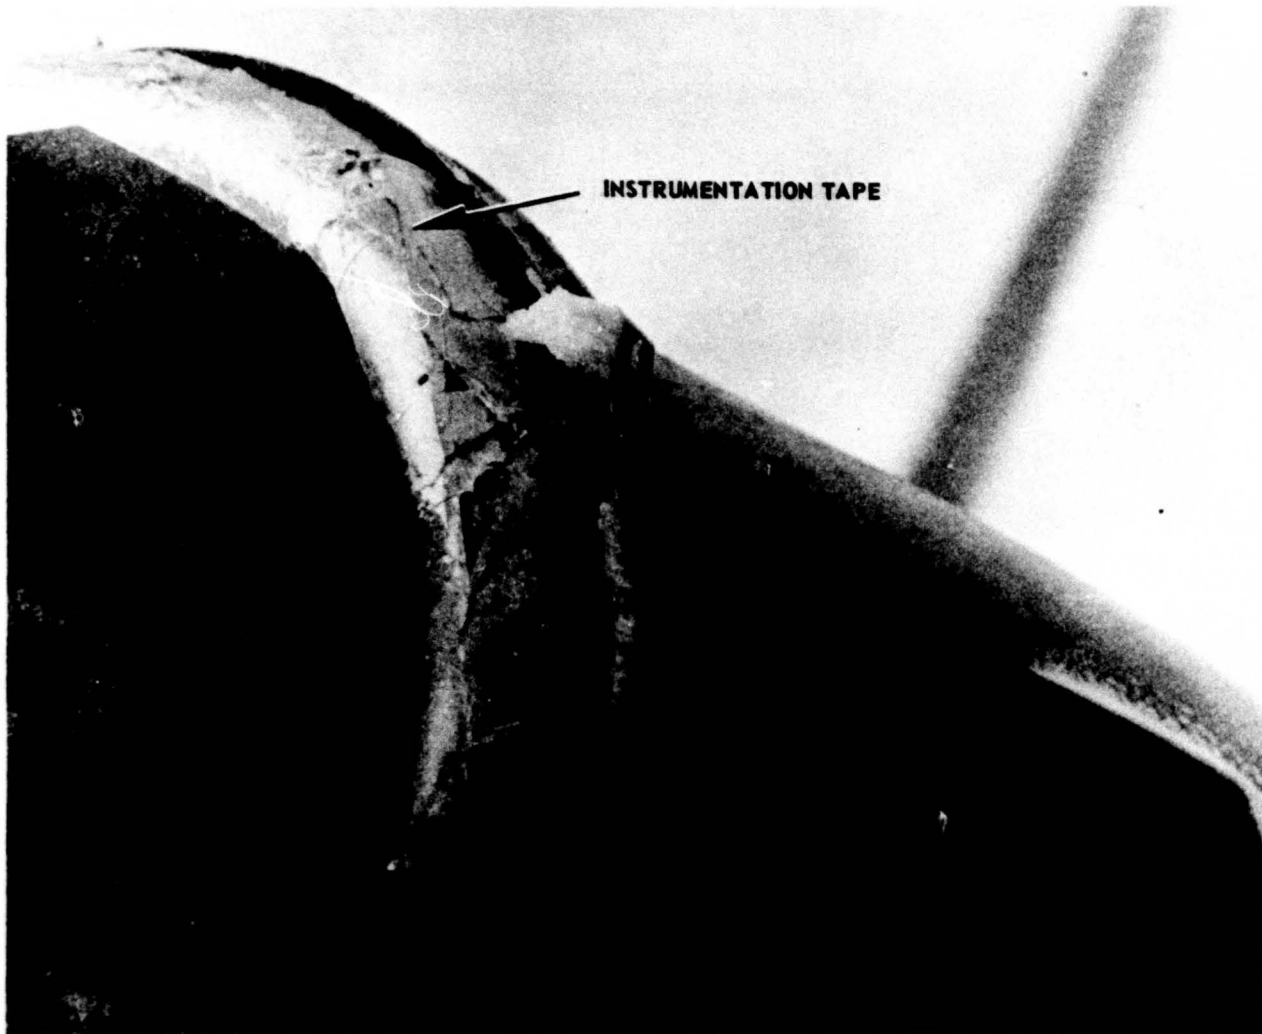
Figure 10 Natural Ice on EAPS Aft Support Rings

The EAPS performed satisfactorily under all natural icing and snow conditions encountered. The EAPS doors were usually left in the open position during cruise until the first indications of icing were observed. At that time, the doors were closed and left closed until the inlet lips and doors were visually checked to be ice free. The maximum amount of natural ice was collected on the EAPS on icing flight 21. About 30 percent of the leading edges of the mini screens on the inboard (vertical) EAPS panel were observed to have rime ice formations.

The EAPS should be cleared for flight in icing conditions up to moderate with the doors closed. If icing conditions are encountered inflight with EAPS installed, the EAPS doors should be closed immediately to prevent the possibility of engine FOD from ice shed from the rotor system or off the EAPS inlet lip or doors. Once closed, the EAPS doors should not be opened again until the EAPS doors are visually checked clear of all ice in flight, or the helicopter is on the ground with the engines stopped. (R 2, R 3, R 4)

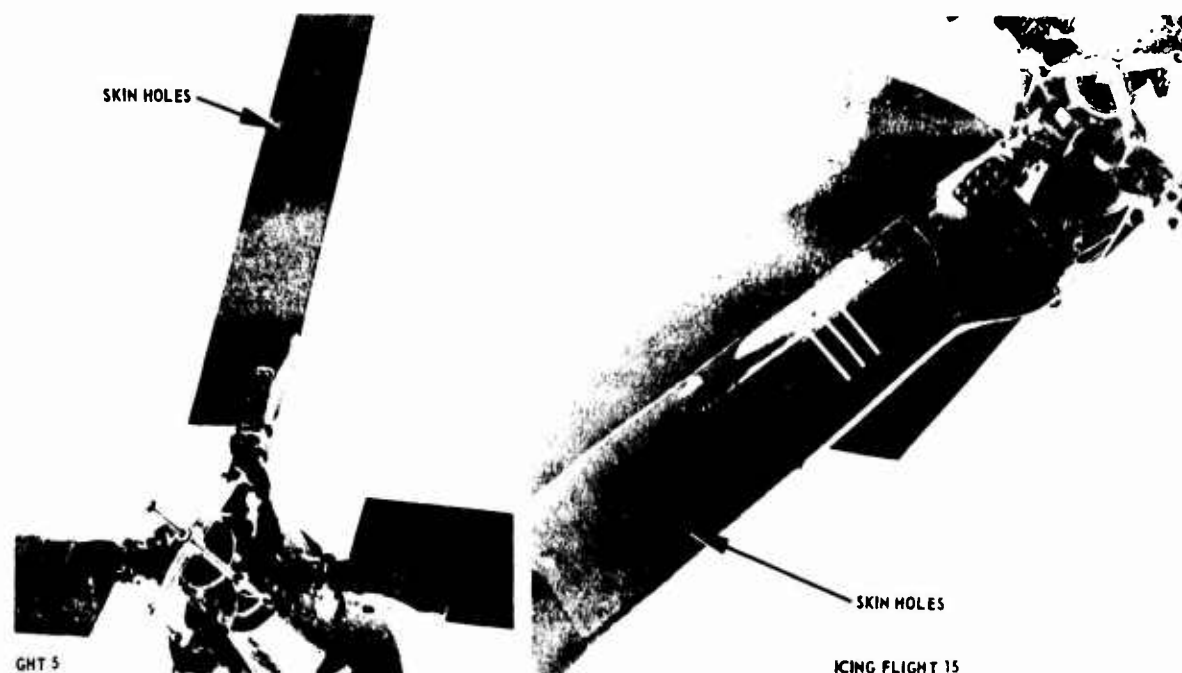
Figure 15 Damage to Tail Rotor Blades

Typical blade ice shedding occurred first from the tail rotor blades and then from the main rotor blades. Shedding usually occurred from the midspan and tip areas, and was generally asymmetric. Main rotor blade ice shedding was random throughout the circumference of rotation, but the ice thickness at which shedding occurred could be predicted, based on the measurement of ice remaining on the rotor blades at the termination of the flight and an assumed approximate average rate of ice accumulation, (appendix IV). Ice from the main and tail rotor blades typically shed when the accumulated ice thicknesses reached approximately $1/2$ and $1/4$ inch, respectively. Tail rotor ice shedding did not cause any airframe damage or aircraft control degradation. Main rotor blade shedding was significant and caused main and tail rotor blade damage and airframe vibrations. Ice shedding that occurred on icing flights 5 and 15 resulted in minor dents and holes on the tail rotor blade pocket skin. After icing flight 5 one tail rotor blade had two holes, $3-3/4$ by 2 inch and 2 by 1 inch, and after icing flight 15 two tail rotor blades had a total of three holes of $7/8$ by $1-1/4$, $1/2$ by $1/4$, $2-1/2$ by $1-1/4$ inch (figure 15). The damage did not degrade the structural integrity of the blades and did

not present any immediate safety of flight hazards. Generally tail rotor blade damage occurred at colder OAT's, when ice accumulated on 100 percent of the main rotor blade span. Colder temperatures (-18 degrees C) caused the ice to form farther out toward the main rotor blade tips, which resulted in a larger angle of incidence between shedding tip ice and the tail rotor blade plane of rotation. Damage, in the form of dents, was inflicted on the tail rotor blades consistently throughout the icing tests, however, the only damage requiring tail rotor blade replacement occurred during icing flights 5 and 15. Main rotor blade damage occurred occasionally in the form of small dents in the pockets due to ice strikes.

Postflight inspection after flight No. 5 revealed tail rotor damage requiring the changing of one blade. Two holes approximately $1 \times 1\frac{1}{2}$ inches were found in the blade pockets on the outer side of the blade. Up to this time, the standard procedure had been to land from a hover following each icing flight. Heavy ice shedding had been observed during the low speed portion of the approach and as the helicopter came to a hover for landing. It should be noted that the pitch of the tail rotor blades was greatest in a hover, exposing a larger area of the tail rotor blade pockets to the rotational axis of the main rotor blades. From these facts and the entry angle on the holes in the tail rotor blade pocket, it was concluded that the damage probably occurred in slow speed flight, in a hover or when changing the tail rotor pitch for ground taxi turns. Later icing flights demonstrated an additional factor could contribute to possible tail rotor pocket damage. As the OAT decreased, the main rotor blades accumulated ice further out the span towards the blade tips. Ice shed from the immediate tip area had a greater tangential velocity and a greater strike angle relative to the tail rotor blade plane of rotation, thus increasing the possibility of an ice strike on a tail rotor blade pocket at such an angle as to cause penetration. In order to reduce

the possibility of tail rotor damage, running landings followed by a straight ahead stop and shutdown were used on all subsequent artificial icing tests. On icing flights 6 through 14, minor pocket dents were found on the tail rotor and main rotor blades following each icing flight. These dents did not require any maintenance action and at no time jeopardized the structural integrity of the rotor blades. Review of high speed films taken from a chase helicopter verified random shedding from the main rotor blades in forward flight and occasional hits on the tail rotor blades.

At no time during the icing tests was it felt that the magnitude of the tail rotor blade dents and punctures experienced in the blade pockets compromised safety of flight. It was concluded from the artificial icing tests that minor rotor blade damage in the form of dents may occur in flight in any icing condition as a result of random ice shedding. Tail rotor damage in the form of skin punctures may occur if ice is shed in slow speed flight, a hover or during taxi turns on the ground. A CAUTION should be added to the Flight Manual, recommending landing procedures when the aircraft has an ice accumulation. (R 6)

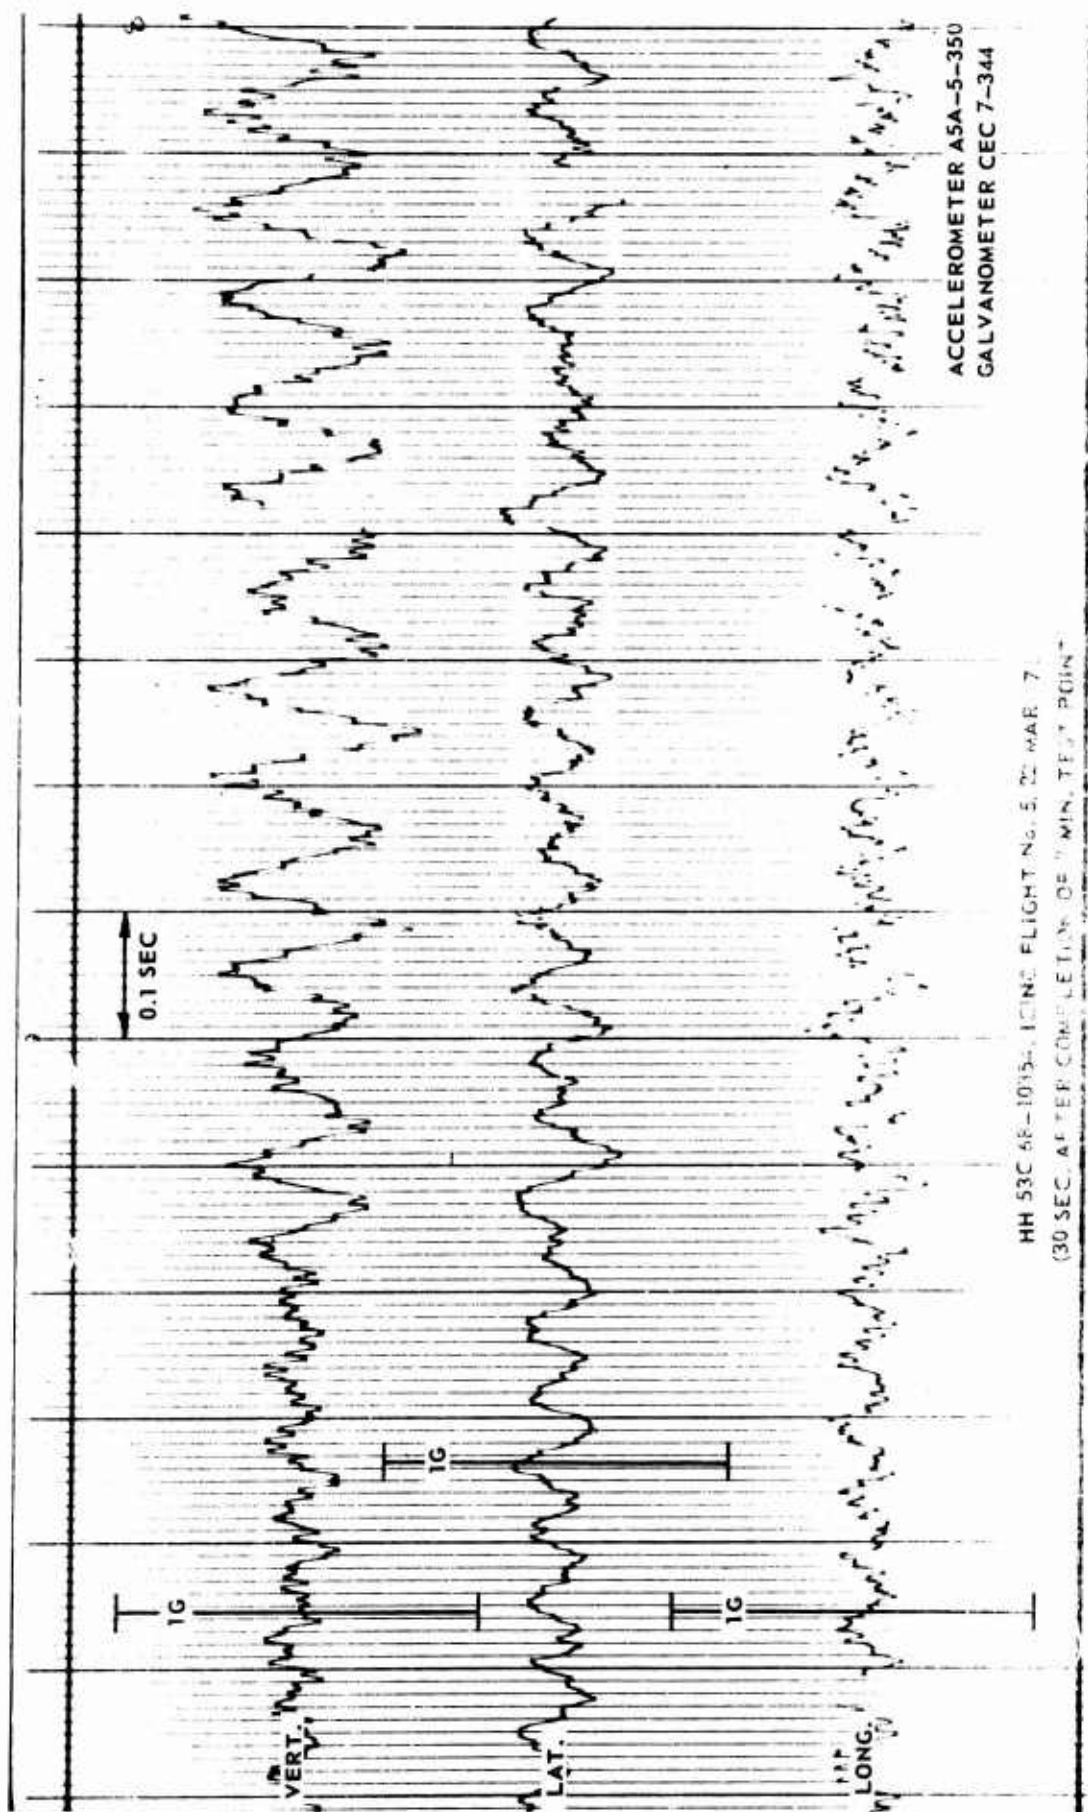
Figure 1. Icing Flight No. 5, 22 MAR 71, 30 SEC AFTER COMPLETION OF 7 MIN. TEST POINT

Icing flights No. 4 and 5 were 7-minute test runs flown in moderate icing conditions. On both flights, a moderate medium frequency vertical vibration built up within 30 seconds after leaving the icing cloud. The vertical accelerometer indicated an increase of $\pm .17$ g within one second and then a further increase of $\pm .08$ g for a total acceleration level of $\pm .34$ g after 16 seconds. These were defined by the pilots as moderate medium frequency vibrations (approximately 13 Hertz) (figure 17).

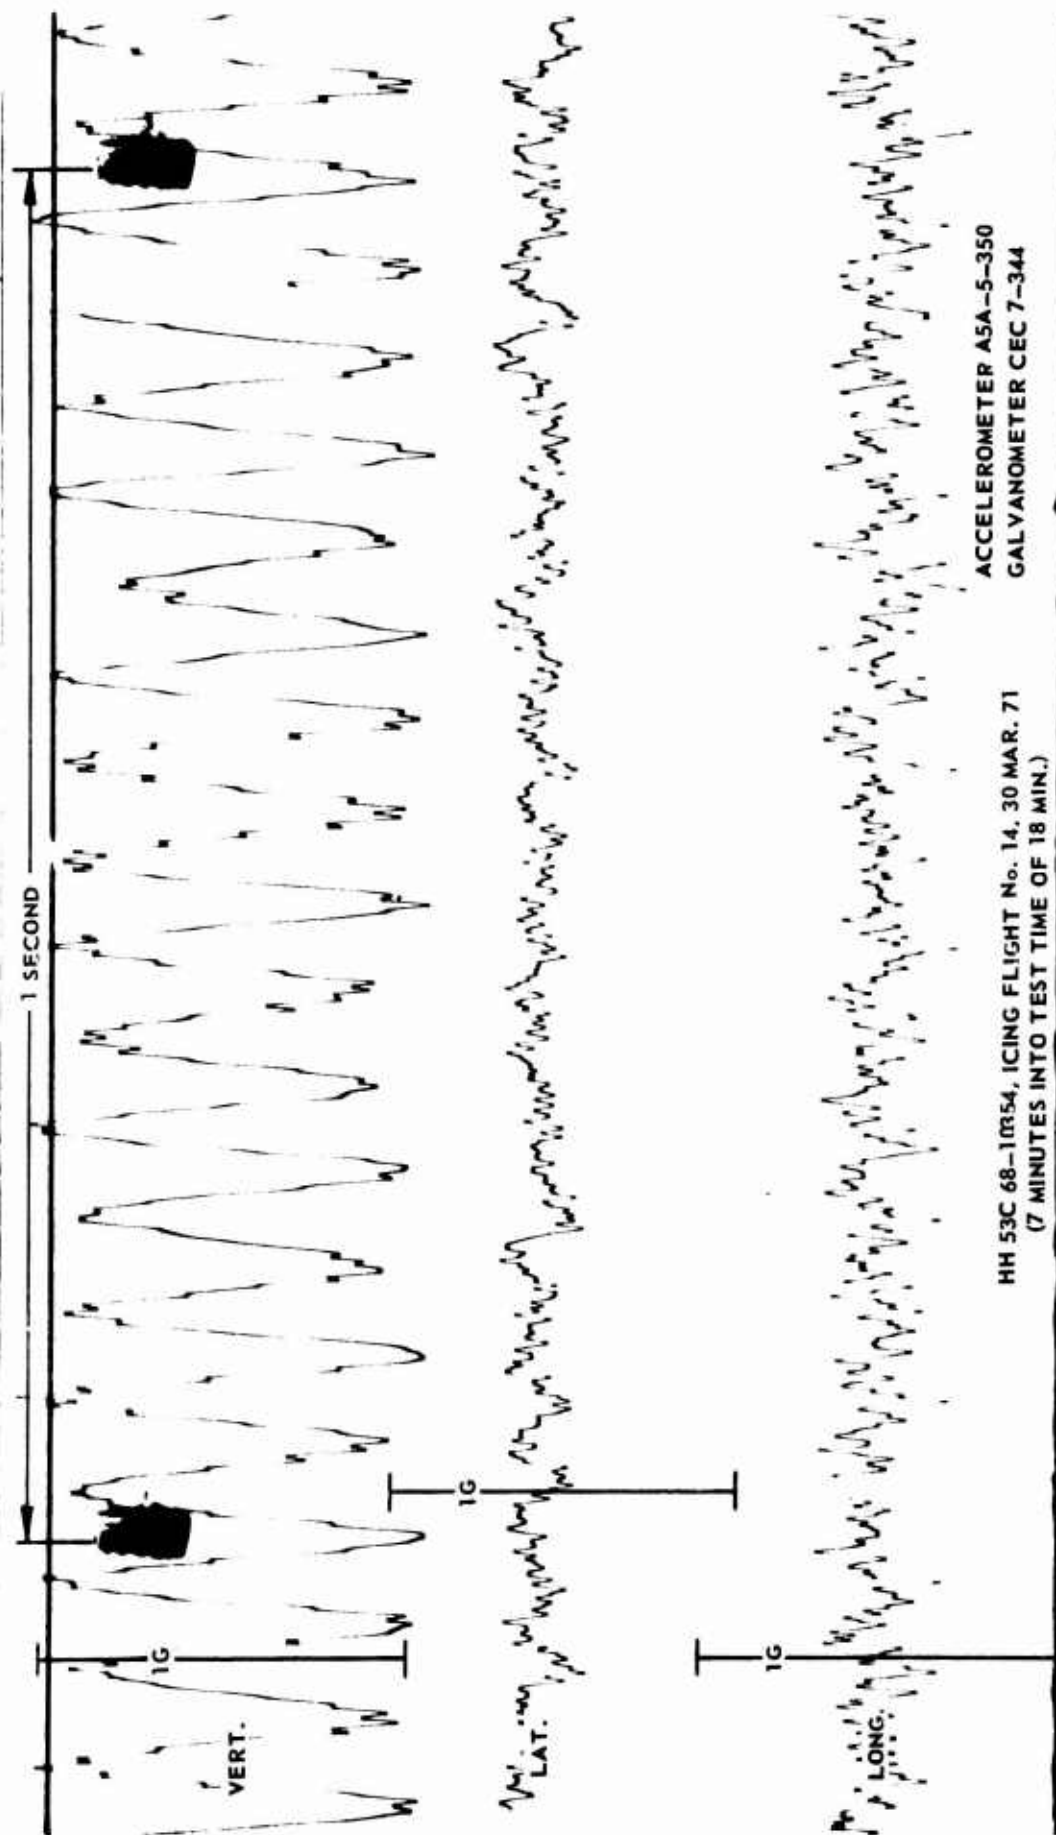
Figure 18 Vibration Change from Ice Shedding

On icing flight No. 5, similar vibrations were experienced after exiting the icing cloud. After both a medium frequency vertical vibration and a lateral shuffle developed, the controls were exercised in an attempt to even the ice shedding on the blades and reduce the vibrations. Moving the cyclic had no effect on the vibration level. Next, the collective was moved full down then up to maximum power. This immediately started a gradual reduction in the vibration level, with the helicopter returning to a more normal vibration level within eight seconds after completion of the collective change. During the eight seconds, the vertical accelerations decreased from $\pm .22$ g to $\pm .12$ g above inherent levels. Vibrations experienced during subsequent flights in similar or heavier icing conditions due to asymmetric ice shedding were reduced or eliminated by varying the rotor rpm from 95 to 105 percent N_r with the speed selectors while maintaining altitude with the collective. This proved to be a more satisfactory method of reducing vibrations than by climbing or descending with a collective change. In either case, the change in main rotor and tail rotor pitch was generally effective in reducing airframe vibrations earlier than would occur without pilot action. It was concluded that a change in rotor rpm by moving the speed selectors was the most effective method in reducing vibrations caused by asymmetric shedding of main and tail rotor blade ice. This would be an acceptable procedure under IFR conditions. A NOTE should be added to the Flight Manual, recommending that rotor rpm be varied when asymmetric ice shedding is encountered. (R 5)

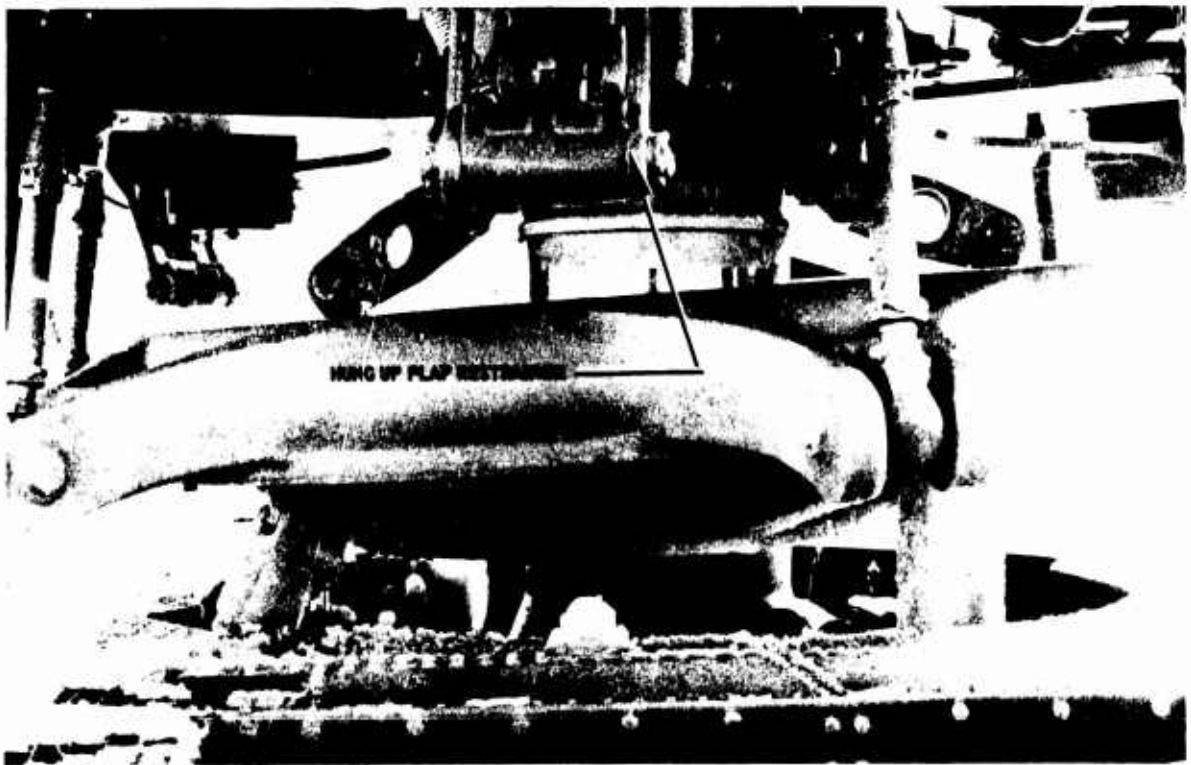
Figure 20 Ice on Flight Servos and Anti-Flapping Restrainers

During artificial icing flights when significant depth of ice was accumulated (1/4 to 1/2 inch, light icing for five minutes and all moderate icing flights) one or more of the main rotor blade anti-flap restrainers hung out in the flight position during rotor shutdown (figure 20). This represented no operational or safety problems during the icing tests since there was no significant wind blowing during shutdowns. The anti-flap restrainers returned to the non-flight position as soon as the ice melted. Pilots and ground crewmen should be alerted for main rotor blade flapping during rotor shutdown in windy conditions after ice has accumulated on the main rotor head. Under these circumstances it will be necessary to park into the wind to minimize chances of blade/fuselage or rotor head damage during shutdown. A CAUTION should be placed in the Flight Manual describing procedures to follow on rotor shutdown after icing conditions have been experienced. (R 9)

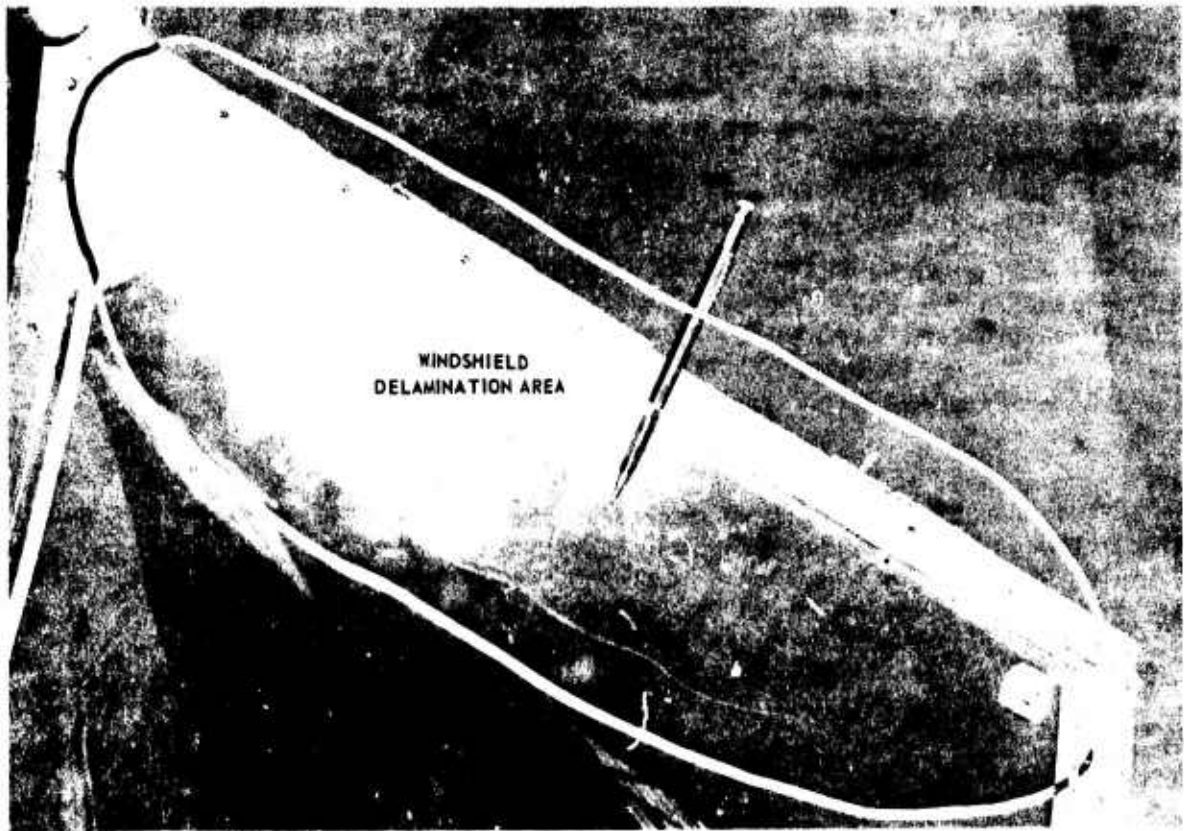
Figure 23 Windshield Delaminations

Two areas of delamination appeared in the center windshield overnight after having been used during the previous days (figure 23).

One third of the center windshield lost all anti-ice capability after icing flight 9. This portion of the windshield had a delamination

in which a burned or smoky area, immediately adjacent to the imbedded bus bar, was visible. The windshield anti-icing systems were in use for approximately 7 hours during the artificial icing tests and approximately 10 hours during the natural icing tests. As evaluated, the windshield anti-icing system was highly effective in maintaining ice free vision up to and including moderate icing conditions when turned on one minute prior to encountering icing conditions. The windshield was unsatisfactory in terms of its extremely short service life when using the anti-ice heating capability, due to frequent delaminations. The quality control inspection procedures employed during manufacturing and acceptance should be improved and/or the windshield design improved to eliminate the delamination problem. (R 19)

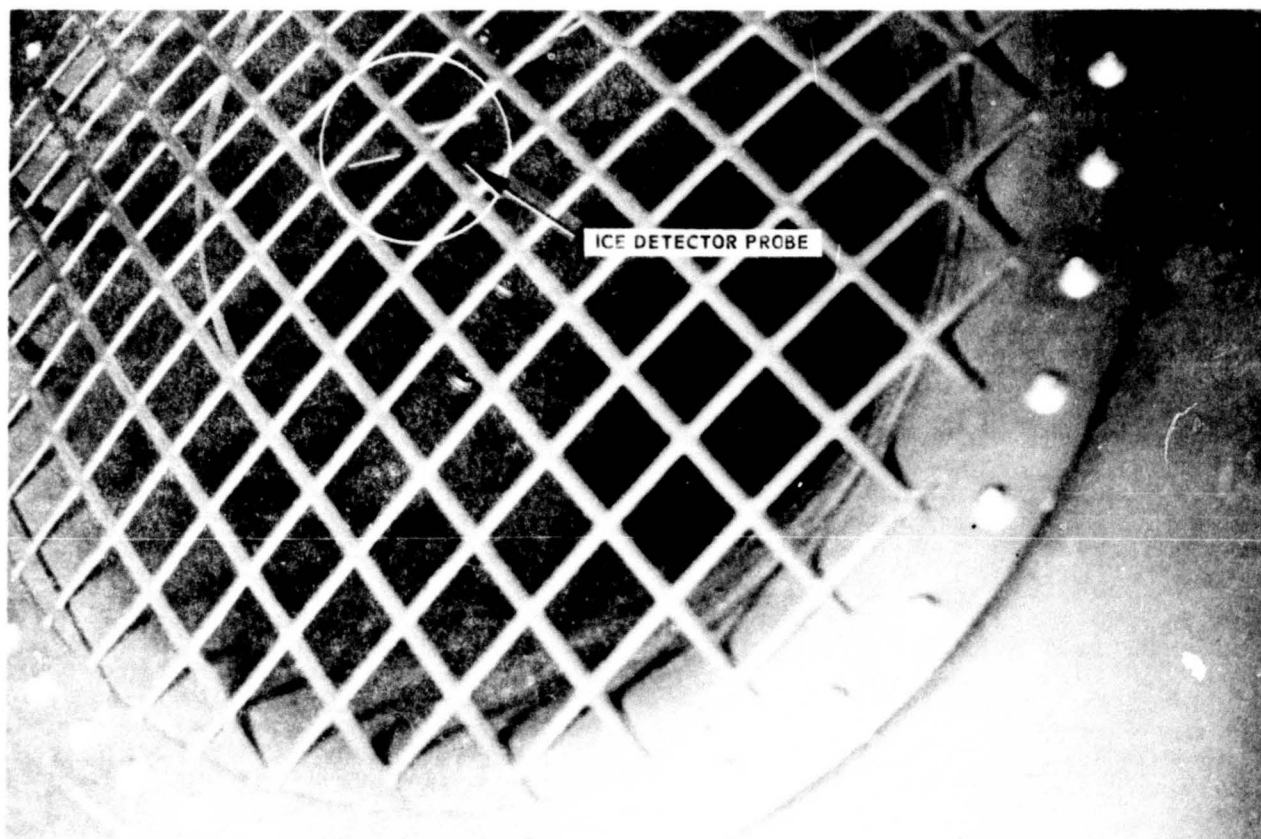
Figure 24 Heater Inlet Screen with Ice Detector Probe Inside

The ice detector probe, located in the cabin heater inlet duct, was unreliable during the test program (appendix VII). During test point 12, an artificial icing condition, the ice detector system did not activate until it had been in a light icing condition for 8 minutes and on other flights it activated frequently, prior to entering the icing cloud. Also, during a flight in search of natural icing, the ice detector system activated in clear air, with no icing evident. The cabin heater was inoperative during part of the artificial icing/freezing rain tests, but was operational during the natural icing test phase.

The intermittent operation of the ice detector probe was possibly caused by its location within the cabin heater duct, and/or air flow blockage due to ice accumulation on the heater screen (figure 24). The ice detector system was unreliable. The operation of the ice detector probe should be checked and the sensor relocated to an area that would be more conducive to ice accretion in unrestricted airflow. (R 27)
